***Proposed Stetson Creek Diversion
2005 Studies Technical Memoranda
Cooper Lake Project (FERC No. 2170)***

**Prepared by
HDR Alaska, Inc.
Cultural Resource Consultants
Land Design North
Northern Ecological Services**

**Prepared for
Chugach Electric Association, Inc.**

August 2005

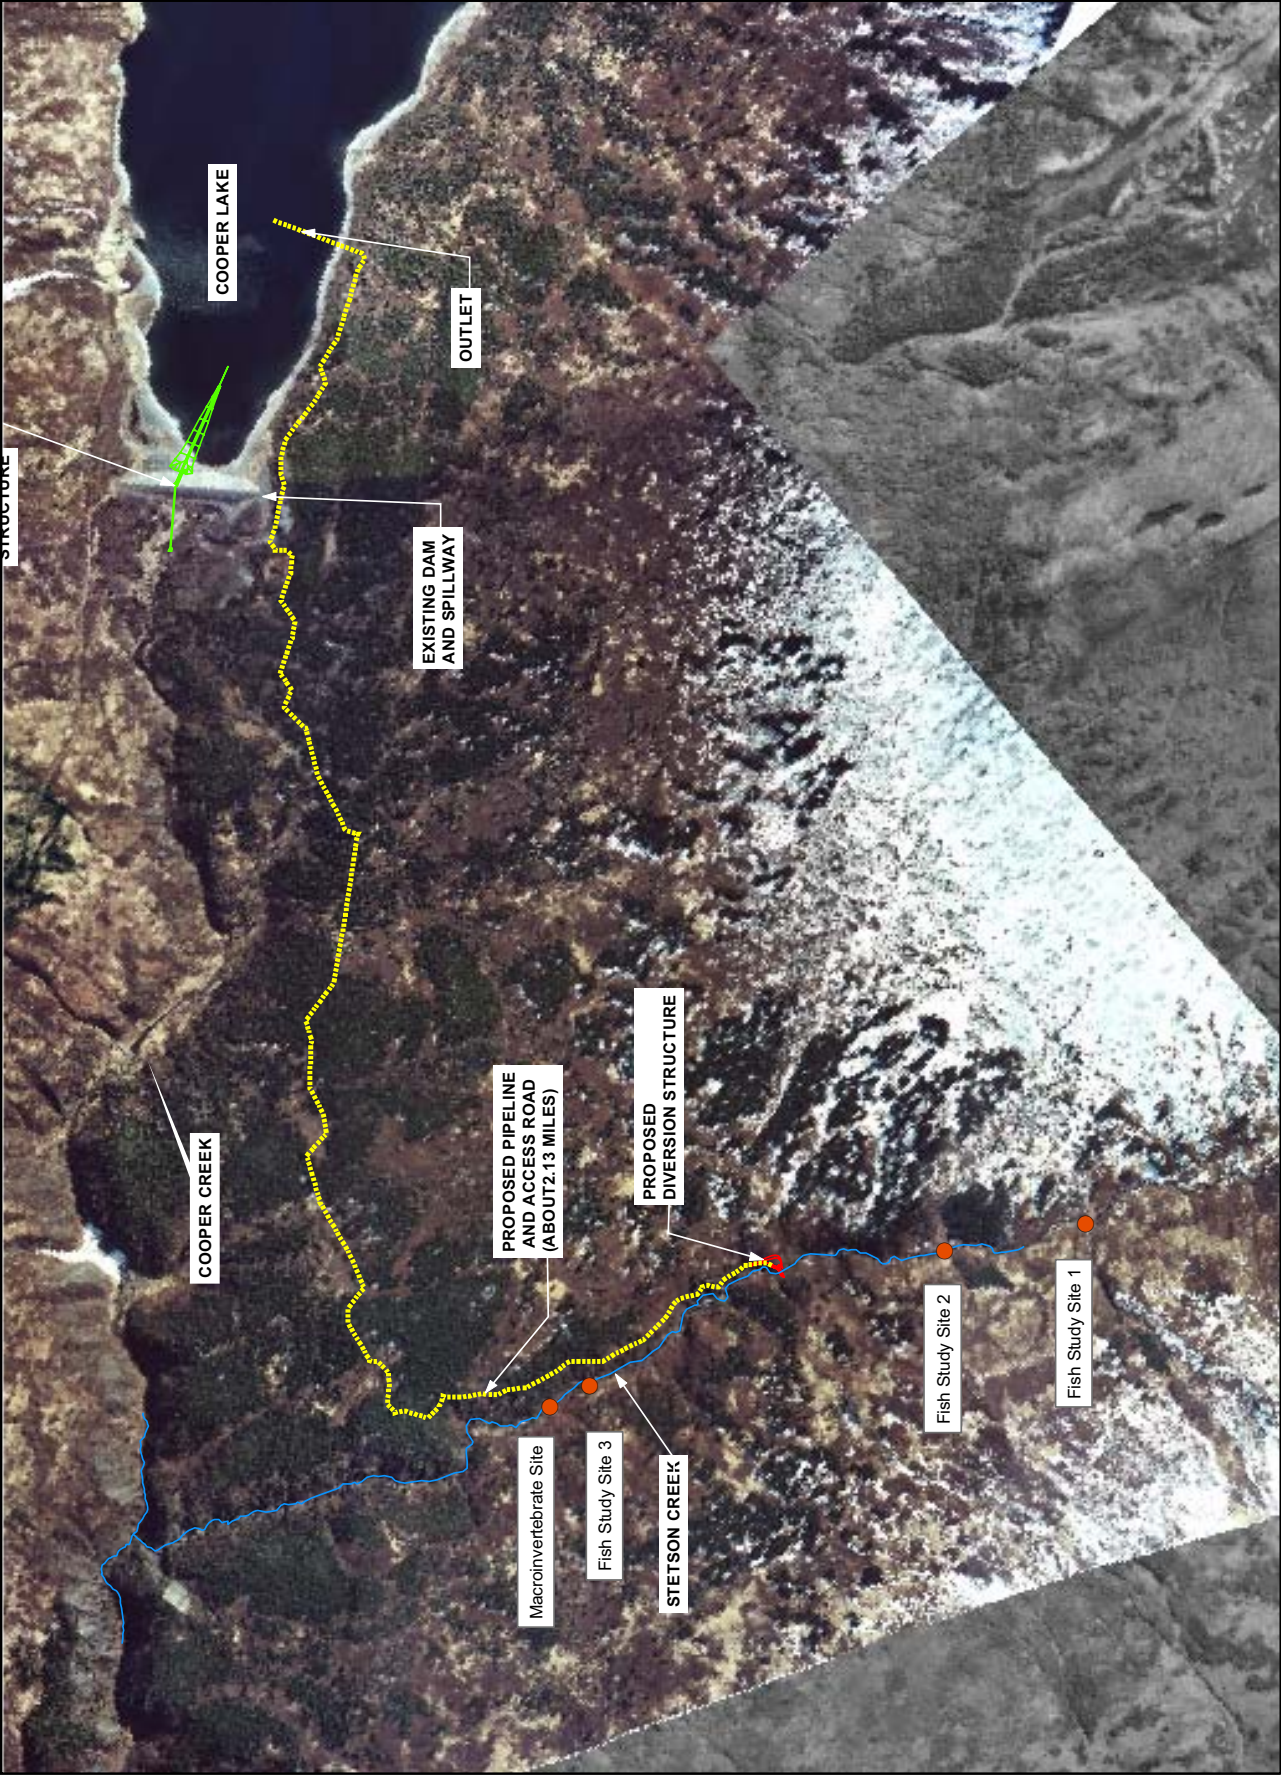
Fish and Macroinvertebrate Study of the Stetson Creek Diversion Pipeline

An additional site was investigated on August 12 in order to incorporate an area farther downstream. The location of Site 3 is shown on Figure 3. A 400 ft. stream reach was

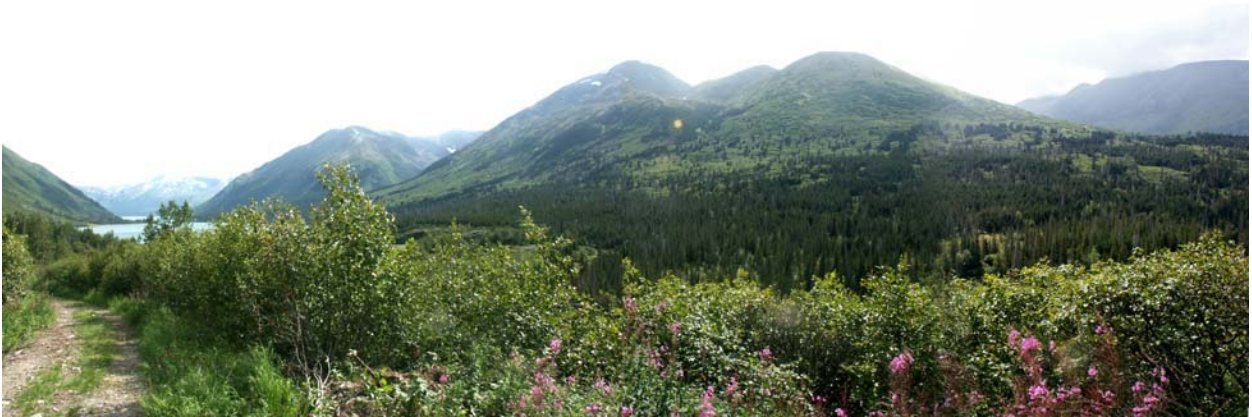
Figure 14. A panoramic view of Cooper Lake and the proposed pipeline / access road area from the Cooper Lake Dam access road, approximately 0.25 mile from the Cooper Lake Dam.

For the next 0.25 mile toward the dam, vegetation borders the road and prevents valley views, but allows the northern portion of Cooper Lake to be seen. For the last approximately 0.25 mile of the road, the vegetation opens up and views are available to the reservoir and Cooper Lake / Cooper Creek valley, with the viewer at a lower elevation than the location of the proposed corridor. Thus there would be views to the proposed corridor (Figure 14), including disruptions in vegetative patterns.
